Water Power

Underwater operations

Underwater services incorporating remotely operated vehicles can help minimise operational impacts at hydro plants while improving regulatory compliance

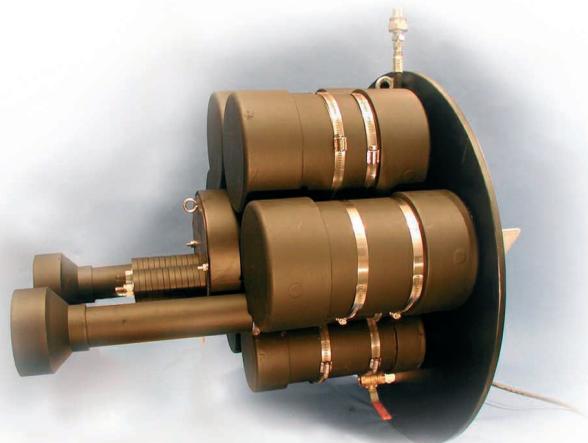
Although ROVs are generally thought of as inspection tools, there exist applications in which manipulators and tooling can also be used to offset cost and risk. A Vehicle Assisted Tool (VAT) was built to temporarily blank a 14" service water intake on the face of a dam. The VAT blanking plug was installed by the ROV in over 36.6m of water, then the ROV separated from the plug and visually verified that it was installed properly. The plug's internal camera showed that the water had been removed from inside the service water line and that the seal had integrity.

VAT Hydraulic Latching Blanking Plug with internal video camera

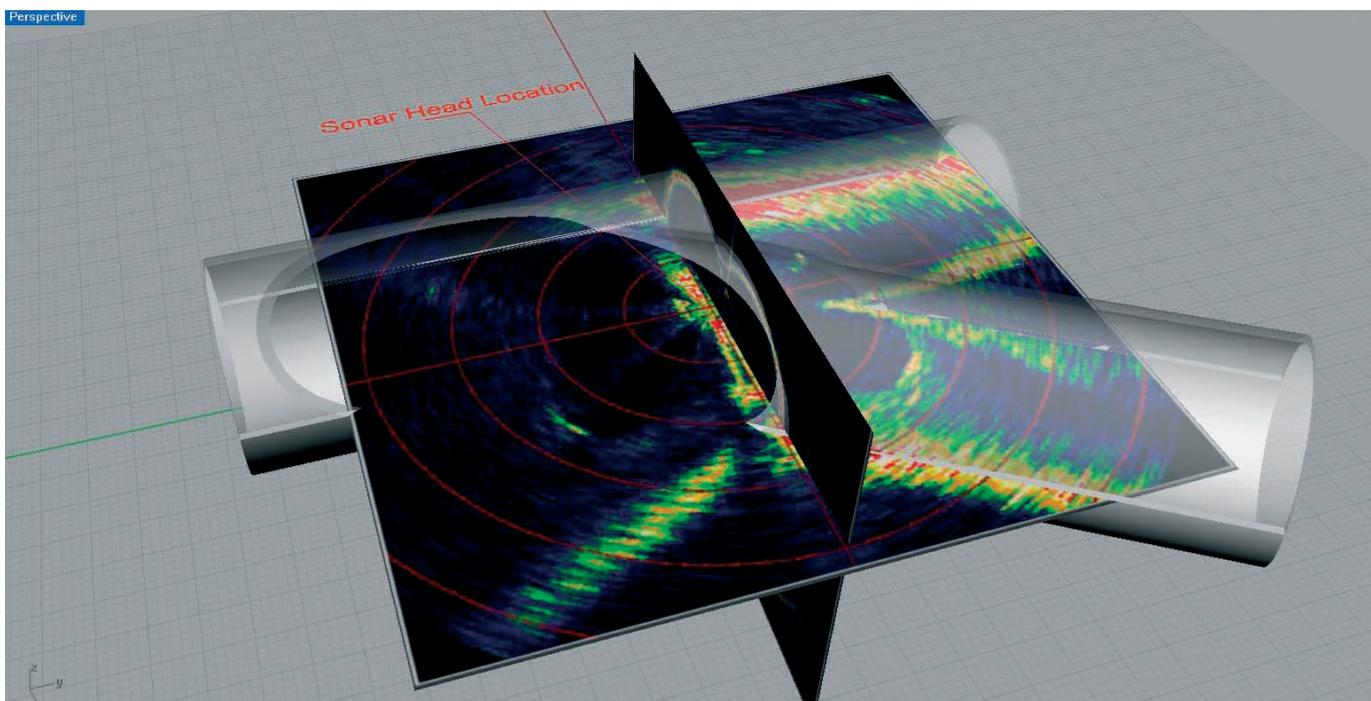
This case involved a pumped storage plant that included a pressure shaft of approximately 304.8m in height, and it had about 1.6km of tunnel to the turbine shutoff valves. The entire inspection was completed in about 20 hours reducing the plant outage to two days. A large Inspection Class ROV with long tunnel capabilities was chosen for the task of sensor delivery. The inspection included high resolution video transmitted by fibre optics to the surface. The imaging sonar system included two sonar heads that worked in a complimentary fashion to take cross sections and image ahead of the ROV to search for features before they were in visual range of the video camera. Even in zero visibility as is the case with large effluent outfalls, the sonar system can complete a detailed inspection. The sonar system was crucial to the inspection process because the combination of sensors provided both long range and short range feature detection that increased both the speed and quality of data recorded. The sonar system was capable of detecting spalls, joints, cracks, debris and many other features far ahead of the ROV. The sonar also created centimetre accurate cross sections that showed debris buildup and depth of spalls, and as well as this the system was also used to navigate through bifurcations and chambers.

Superimposed sonar views with CAD of bifurcation
